Subject: First Year Wetland and Stream Monitoring Report, Bledsoe County Correctional Complex, Pikeville, TN

First Year Wetland and Stream Mitigation Monitoring Report
Bledsoe County Correctional Complex
Pikeville, Bledsoe County, Tennessee
(DOA File/Permit 200502425)
(TDEC §401 Water Quality Certification 09.009)

Mitigation Site Name: Bledsoe County Correctional Complex (BCCX), Pikeville, TN

Monitoring Dates: September 26-30, 2011 (First Year Monitoring)

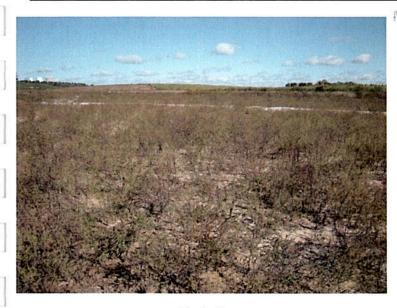
Photo 1.

Dominant Vegetation: common ragweed (Facu), three-seeded mercury (Fac-), yellow foxtail grass (Fac)

Comments: Wetland creation areas are strongly dominated by common ragweed which accounts for nearly 14% of herbaceous cover.

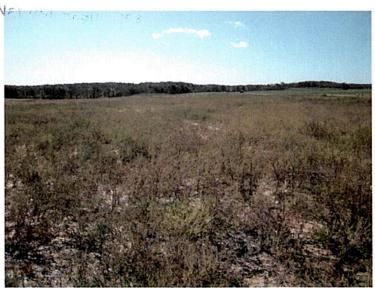
Photo 2.

Creation Area, Photo Reference Point C2: South

Dominant Vegetation: common ragweed (Facu), three-seeded mercury (Fac-), smooth paspalum (Facw-)

Comments: Soils within the creation area are low in organics and have been eroded in some locations. As a result, bare soils and other non-vegetated substrates currently occupy, on average, about 56% of the surface area.

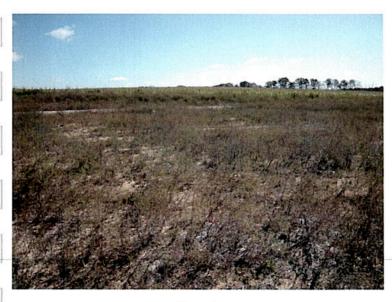
Photo 3.

Creation Area, Photo Reference Point C2: East

Dominant Vegetation: common ragweed (Facu), three-seeded mercury (Fac-)

Comments: Weather extremes have also probably played a roll in slowing the establishment of herbs. After a wet winter and spring, combined rainfall for July and August totaled just over 2 inches.

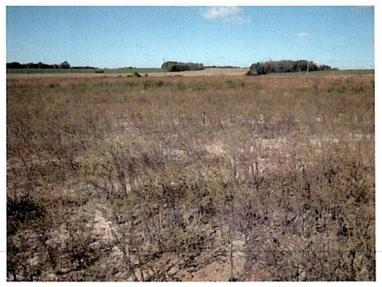
Photo 4.

Creation Area, Photo Reference Point C2: West

Dominant Vegetation: : common ragweed (Facu), three-seeded mercury (Fac-)

Comments: Many portions of the creation area are underlain with a hard, compacted layer (fragipan). This physical obstruction slows the downward movement of water after precipitation events.

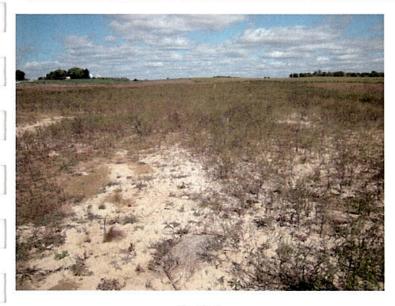
Photo 5.

Creation Area, Photo Reference Point C4: North

Dominant Vegetation: common ragweed (Facu), smooth crab grass (Upl)

Comments: Sparse vegetation in this part of the site is primarily the result of prolonged ponding of water. Saturated soils are visible at photo left.

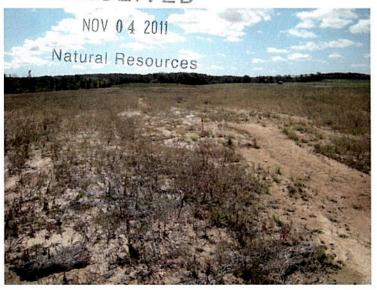
Photo 6.

Creation Area, Photo Reference Point C4: South

Dominant Vegetation: common ragweed (Facu), greater poverty rush (Fac?), grass-leaved rush

Comments: Note the water-scoured soils in the right of this view. Drift lines composed of straw that had been used in effort to stabilize the site can also be seen in the foreground.

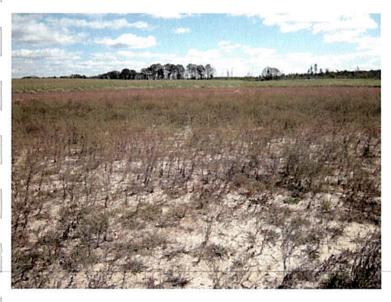
Photo 7.

Creation Area, Photo Reference Point C4: East

Dominant Vegetation: common ragweed (Facu), smooth crab grass (Upl)

Comments: Other evidence of surface hydrology includes soil cracking, especially in areas of silt accumulation.

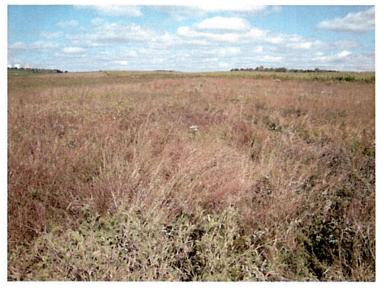
Photo 9.

Enhancement Area, Photo Reference Point E1: North

Comments: Dense stands of native grasses and forbs were found throughout each of the enhancement areas.

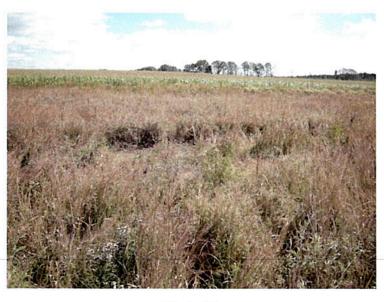
Photo 11.

Enhancement Area, Photo Reference Point E1: East

Dominant Vegetation: redtop panic grass (Facw), clustered mountainmint (Fac), cypress witch grass (Fac), boneset (Facw+)

Comments: Residual wetland shrubs contributed considerably to woody plant densities. Swamp rose alone was found to occur at the average rate of 83 stems/ac.

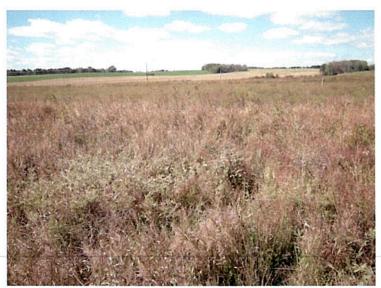
Photo 12.

Enhancement Area, Photo Reference Point E1: West

Dominant Vegetation: redtop panic grass (Facw), clustered mountainmint (Fac), cypress witch grass (Fac), Maryland meadowbeauty (Facw+)

Comments: Most soils in enhancement areas were moist at the time of the field survey but not saturated.

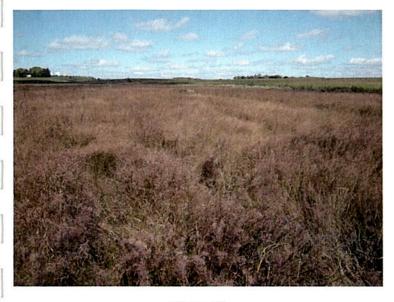
Photo 13.

Enhancement Area, Photo Reference Point E3: North

Dominant Vegetation: redtop panic grass (Facw), broom panic grass (Facw), clustered mountainmint (Fac), Maryland meadowbeauty (Facw+)

Comments: Dense stands of native grasses and forbs were found throughout each of the enhancement areas.

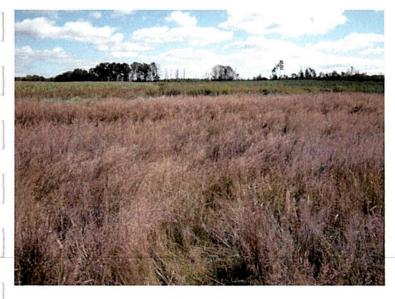
Photo 15.

Enhancement Area, Photo Reference Point E3: East

Dominant Vegetation: redtop panic grass (Facw), clustered mountainmint (Fac), cypress witch grass (Fac), boneset (Facw+)

Comments: Residual wetland shrubs contributed considerably to woody plant densities. Swamp rose alone was found to occur at the average rate of 83 stems/ac.

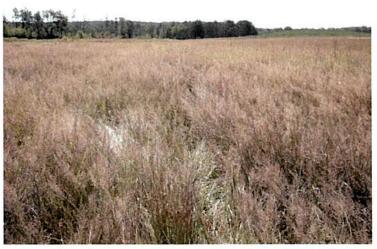
Photo 14.

Enhancement Area, Photo Reference Point E3: South

Dominant Vegetation: redtop panic grass (Facw), tall ironweed (Fac+)

Comments: Presumably because of the density of these wetland species, planted tree seedlings had difficulty competing. Survivorship averaged only 67 stems/ac across all enhancement areas.

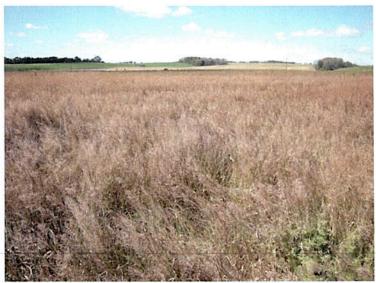
Photo 16.

Enhancement Area, Photo Reference Point E3: West

Dominant Vegetation: redtop panic grass (Facw), clustered mountainmint (Fac), cypress witch grass (Fac), Maryland meadowbeauty (Facw+)

Comments: Actual densities may prove to be somewhat higher than reported since small seedlings were very difficult to find in the thick cover of herbs and grasses.

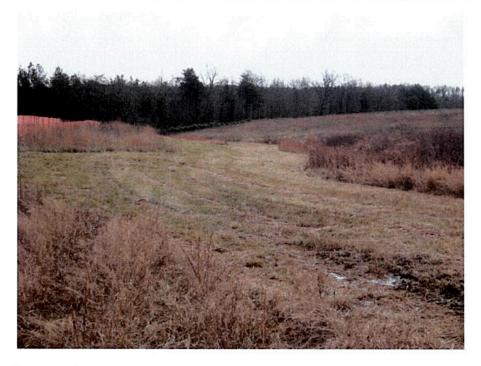
Photo 21. Upland Buffer Zones: Twenty-five ft-wide buffers, external to riparian buffers, were planted with upland oak species in order to provide extra protection to the restored streams. Areas were first mown to make planting easier. Current oak survivorship averages about 200 stems/ac. A portion of Stream 1 lies in the center left of the photo.

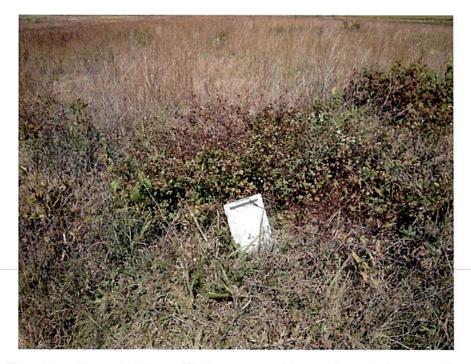
Photo 22. Gooseberry Transplant Area: Nineteen rare granite gooseberry shrubs, rescued from the prison construction site, and transplanted to the mitigation area in 2009, have survived and appear to be thriving. Total shrub cover is about 1,990 ft².

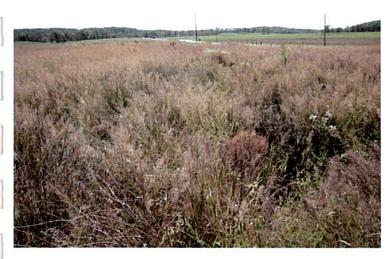
Photo 23.

Dominant Vegetation: redtop panic grass (Facw), wool-grass (Obl), Maryland meadowbeauty (Facw+)

Comments: Planted stream alder, buttonbush, and black chokeberry were found scattered at this location.

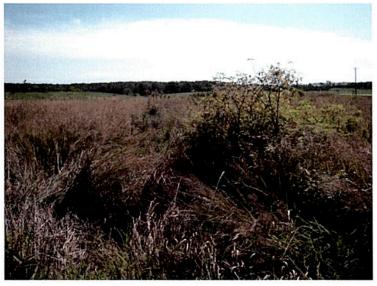
Photo 24.

Stream 1 Enhancement Area, Photo Reference Point 2:

Dominant Vegetation: redtop panic grass (Facw), soft rush (Facw+), elderberry (Facw-)

Comments: One of the site's planted elderberries is visible here.

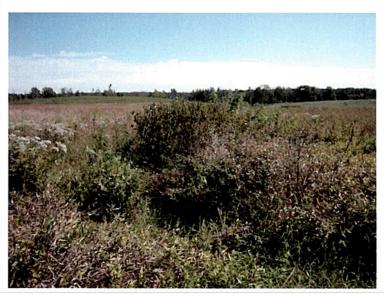
Photo 25.

Stream 1 Enhancement Area, Photo Reference Point 3:

Dominant Vegetation: deer tongue grass (Facw), late-flowering thoroughwort (Fac), silky dogwood (Facw+).

Comments: As was often the case, this site contained both planted and naturally-occurring silky dogwood. Distinguishing between the two was not always possible in some areas.

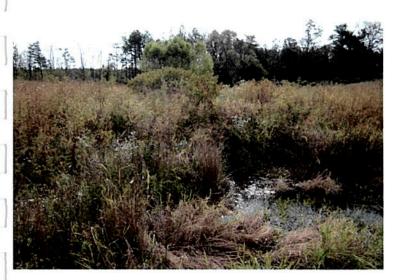
Photo 27.

Stream 1 Enhancement Area, Photo Reference Point 5:

Dominant Vegetation: rice cut grass (Obl), small-flowered agrimony (Fac), silky dogwood (Facw+), black willow (Obl)

Comments: The downstream end of Stream Segment 1 contained more mature residual tree species such as the black willow in the distance.

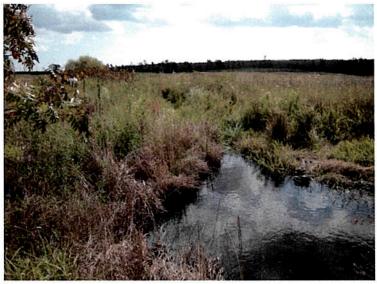
Photo 28.

Stream 2 Enhancement Area, Photo Reference Point 1:

Dominant Vegetation: rice cut grass (Obl), soft rush (Facw+), Georgia bulrush (Obl), winged sumac (Facu-)

Comments: At 135 stems/100 ft of stream, Stream Segment 2 supported the highest density of planted and naturally invasive woody species. The plunge pool in the foreground lies just downstream of two culverts which pass beneath SR 301. It gives a much exaggerated impression of the size of the waterway.

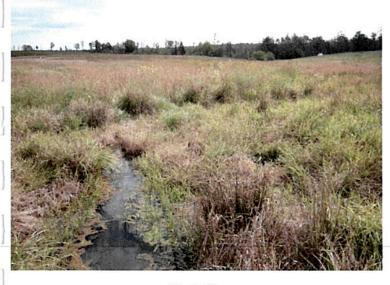
Photo 29.

Stream 1 Enhancement Area 3, Photo Reference Point 1:

Dominant Vegetation: rice cut grass (Obl), soft rush (Facw+)

Comments: By contrast, Stream Segment 3 had the lowest density at just 16 stems/100 ft. Again, the plunge pool gives a false impression about the size of the waterway.

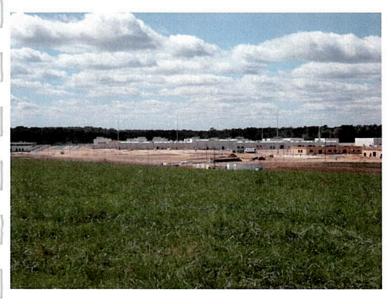
Photo 31.

Photo Supplement, Prison Construction:

Comments: Construction of the prison expansion complex continues with completion scheduled for November 2012.

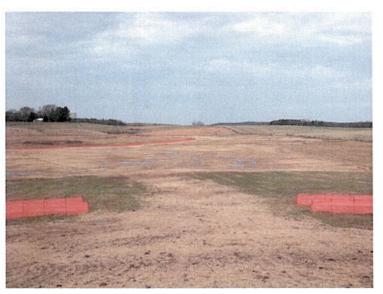
Photo 32.

Photo Supplement, Wetland Creation:

Comments: Grading of the wetland creation area was completed in October 2010. Unfortunately, even though the site was seeded with stabilizing grasses and mulched, it took place too late in the season for germination to take place. This view is looking north from the soil disposal area.

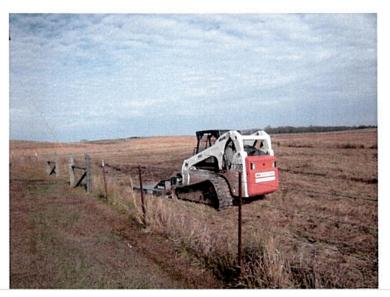
Photo 34.

Photo Supplement, Wetland Enhancement

Comments: Wetland enhancement involved planting tree seedlings in degraded seepage wetlands that had been occasionally grazed by cattle or cut over for hay. Like the created wetland, these areas are to be protected in perpetuity from activities that are incompatible with full wetland functioning, including agriculture. Because the native grasses were so dense, they had to be mown first to facilitate tree planting.

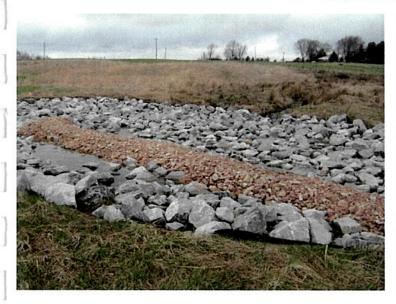
Photo 35.

Photo Supplement, Wetland Creation:

Comments: This spreader pond was installed in an effort to more evenly distribute water entering the site from the north into the various parts of the mitigation area. Extremely heavy rains, particularly in March 2011, overwhelmed the structure and caused flooding of the wetland creation site.

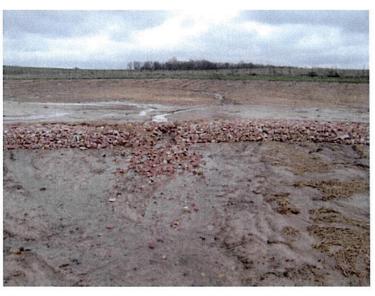
Photo 36.

Photo Supplement, Wetland Creation:

Comments: This produced a cascading effect which then blew out this down-gradient spreader berm. The berm has since been repaired.

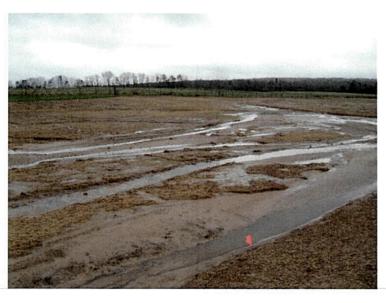
Photo 37.

Photo Supplement, Wetland Creation:

Comments: Numerous erosion channels formed and stripped some of the A-soil horizons. Note the straw mulch which proved ineffectual in preventing scouring. During the growing season the most prominent channels were blocked by installing coir logs to slow water flow and discourage further down-cutting. Establishment of an herb cover will be critical to the future stability of this area. Tree seedlings will also have to be replanted.

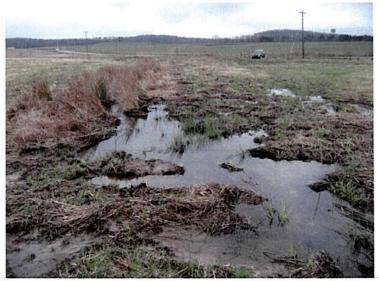
Photo 38.

Photo Supplement, Wetland Enhancement

Comments: By contrast, wetland enhancement areas which were also flooded, sustained very little erosion damage since they contained established plant cover.
